SUBJ: Opportunity to Show Cause
Resource Conservation and Recovery Act (RCRA) Compliance Evaluation Inspection (CEI)
Heritage-Crystal Clean, LLC EPA ID # GAR000078279

RCRA Inspection Report

Photographs of Heritage – Crystal Clean taken by Alan Newman
6140 Purdue Dr., Suite A
Atlanta, GA. 30336
EPA ID # GAR000078279
October 25, 2017

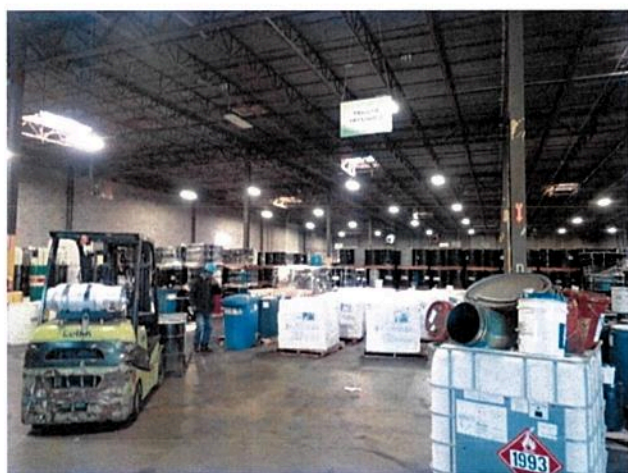
Mr. Bellamy led the inspectors to the delivery loading and unloading areas (Photos 1 and 2 of 24). At the time of the inspection, there were two trucks making deliveries. Mr. Bellamy stated that each delivery generally is comprised of containers from multiple customer facilities. Once the containers are delivered to the HCC Hub, containers from large quantity generators are logged and waste that is to be transported via truck is moved from the unloading area to the loading area by Mr. "Elvis" Christopher Elam, Fork Lift Technician. All used 142-solvent delivered to HCC is centrally staged in the warehouse until it can be captured and transferred into railcars located behind the facility. The used 142-solvent is sent for recycling via railcar to a HCC location in Indianapolis, Indiana EPA ID# IND984869743.

Photo 1 of 24: HCC Warehouse floor

Photo 2 of 24: HCC Warehouse floor

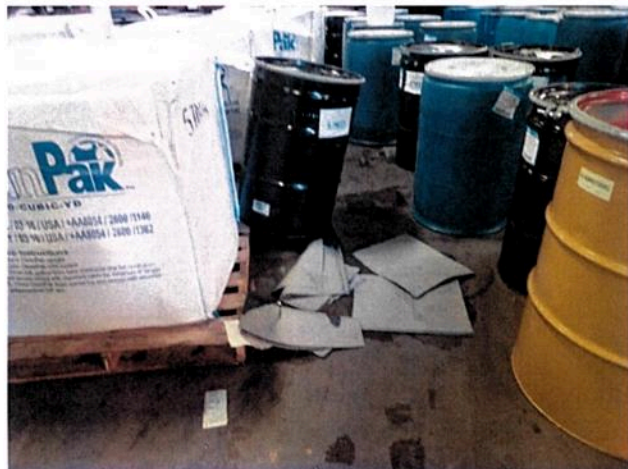
Photo 3 of 24: Drop-off/staging area.

The inspection team noticed several containers of hazardous waste that were leaking, warped, dented, rusted, or otherwise did not appear to be suitable for storing hazardous waste (Photo 3 of 24). Mr. Bellamy stated that if a container is not in good condition upon arrival to the HCC Hub, it is marked for return. Additionally, if during the transportation process, for example, if an HCC worker were to puncture a container with a fork lift, they would place the 55-gallon container in an 85-gallon over pack container and pack it with appropriate absorbent material.

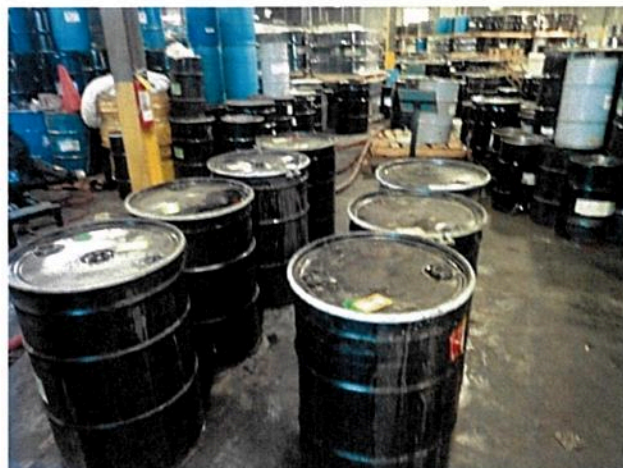
Photo 4 of 24: HCC 90-day hazardous waste (HW) storage area

The inspectors identified seven 55-gallon hazardous waste labeled containers in the 90-day or less container storage area (Photo 4 of 24). At the time of the inspection, each container was identified to store waste codes D001, D006 and D008. One 55-gallon container was not closed (Photo 5 of 24) and another container had waste on the outside of the container.

Pursuant to Ga. Comp. R. and Regs. 391-3-11-.08(1) [40 C.F.R. § 262.34(a)(1)(i) (2016)], which incorporates Ga. Comp. R. and Regs. 391-3-11-.10(1) [40 C.F.R. § 265.173(a) (2016)], and is a condition of the LQG Permit Exemption, a generator is required to keep containers of hazardous waste closed when waste is not being added or removed.

Pursuant to Ga. Comp. R. and Regs. 391-3-11-.08(1) [40 C.F.R. § 262.34(a)(4) (2016)], which incorporates Ga. Comp. R. and Regs. 391-3-11-.10(1) [40 C.F.R. § 265.31 (2016)], and is a condition of the LQG Permit Exemption, a generator is required to maintain and operate its facility to minimize the possibility of a fire, explosion, or any unplanned sudden

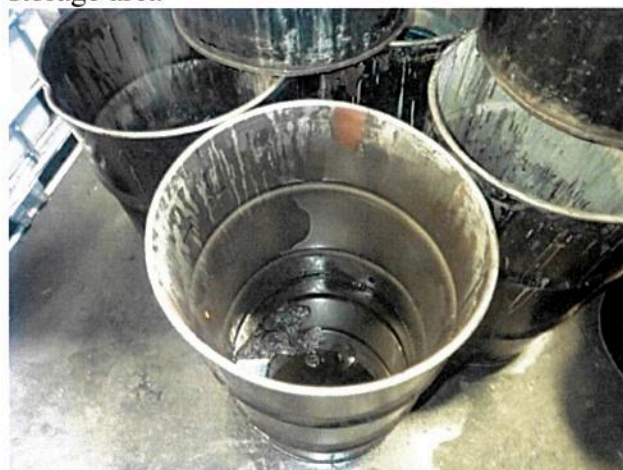
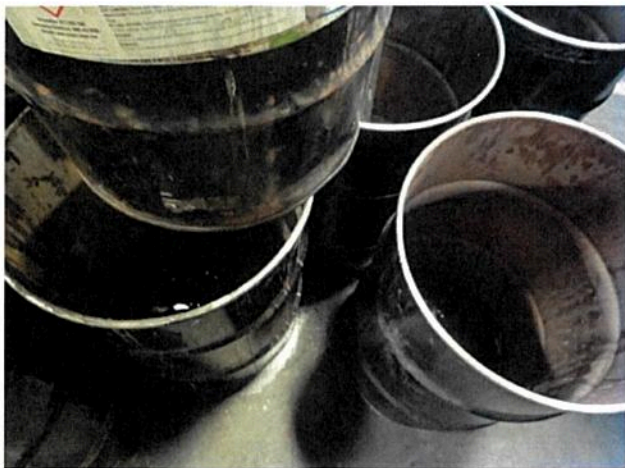
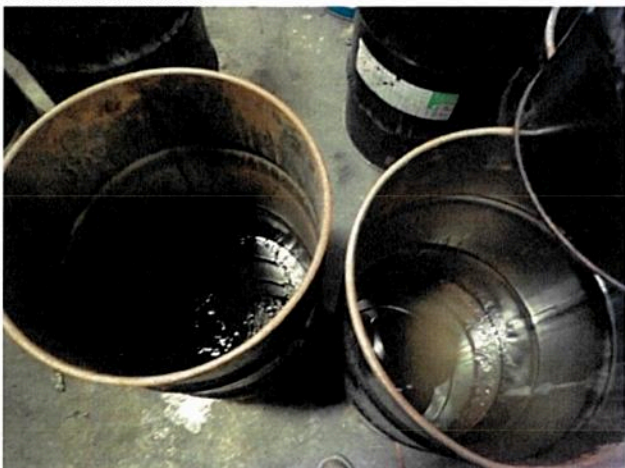
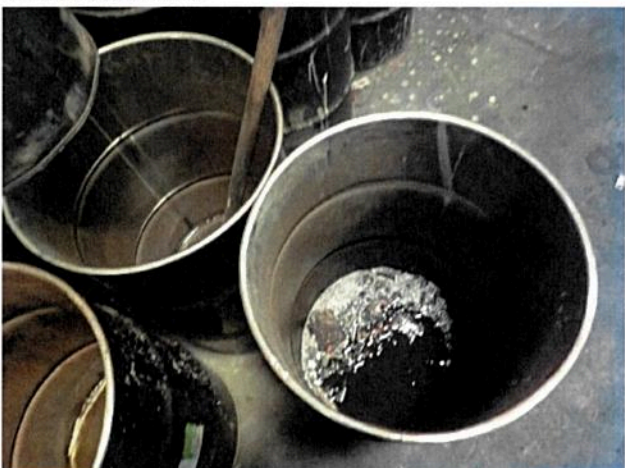
Once the used 142-solvent is transferred from the container to the railcar, the facility consolidates the sludge into 55-gallon containers and identifies the sludge as hazardous waste. At the time of the inspection, there were several hundred, possibly 1,000, open containers that previously contained the 142-solvent. The inspectors identified several open containers that contained a sludge or a sludge-solvent mixture (Photos 6-10 of 24).

Photo 6 of 24: Containers with sludge waiting to be consolidated

Photo 7 of 24: Containers with sludge waiting to be consolidated

Photo 10 of 24: Containers with sludge waiting to be consolidated

Photo 8 of 24: Containers with sludge waiting to be consolidated

Photo 9 of 24: Containers with sludge waiting to be consolidated

Pursuant to Ga. Comp. R. and Regs. 391-3-11-.08(1) [40 C.F.R. § 262.11 (2016)], a person who generates a solid waste, as defined in Ga. Comp. R. and Regs. 391-3-11-.07(1) [40 C.F.R. § 261.2], must determine if that waste is a hazardous waste following the methods articulated in Ga. Comp. R. and Regs. 391-3-11-.08(1) [40 C.F.R. § 262.11 (2016)].

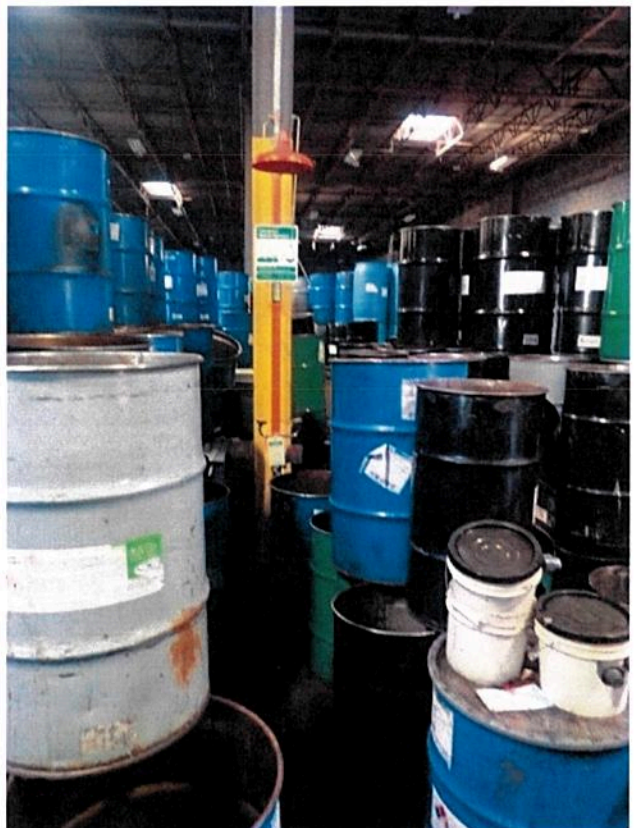
Photo 11 of 24: Staging area for sludge containers and eye wash

The inspection team noticed that multiple containers prevented direct access to an eye-wash location. The inspectors stated that a clear and direct path is needed. (Photo 11 of 24).

Pursuant to Ga. Comp. R. and Regs. 391-3-11-.08(1) [40 C.F.R. § 262.34(a)(4) (2016)], which incorporates Ga. Comp. R. and Regs. 391-3-11-.10(1) [40 C.F.R. § 265.35 (2016)], and is a condition of the LQG Permit Exemption, a generator is required to maintain aisle space to allow the unobstructed movement of personnel, fire protection equipment, spill control equipment, and decontamination equipment to any area of facility operation in an emergency, unless aisle space is not needed for any of these purposes.

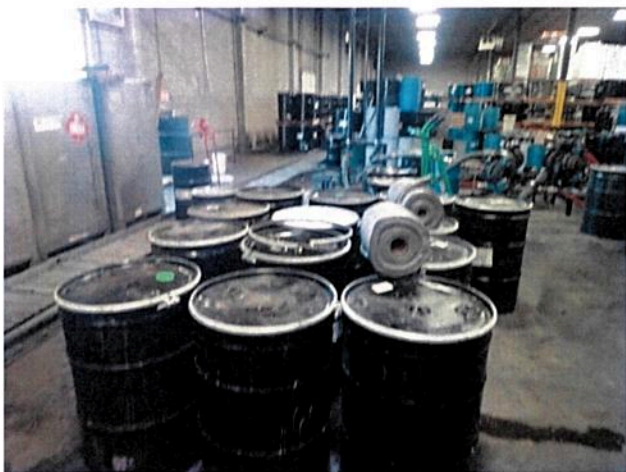
Photo 12 of 24: Satellite Accumulation Area

The facility stated that the remaining sludge from the used 142-solvent is consolidated in 55-gallon containers and stored in the facility designated satellite accumulation area (SAA). At the time of the inspection, there were 13 55-gallon containers in the facility designated SAA that were not labeled with the words "Hazardous Waste" or other descriptive wording (Photo 12 of 24). Mr. Bellamy stated that the containers had been in this area for approximately one month.

Up to 55-gallons of waste may be stored in a satellite accumulation area. Once the volume of waste exceeds 55-gallons, within three days, the waste should be moved to a 90-day storage area. Wastes not moved within three days should be managed as wastes in a 90-day drum.

Pursuant to Ga. Comp. R. and Regs. 391-3-11-.08(1) [40 C.F.R. § 262.34(a)(2) (2016)], which is a condition of the LQG Permit Exemption, a generator is required to ensure that the date upon which each period of accumulation begins is clearly marked and visible on each container.

Pursuant to Ga. Comp. R. and Regs. 391-3-11-.08(1) [40 C.F.R. § 262.34(a)(3) (2016)], which is a condition of the LQG Permit Exemption, a generator is required to label or clearly mark each container and tank accumulating hazardous waste on-site with the words: "Hazardous Waste."

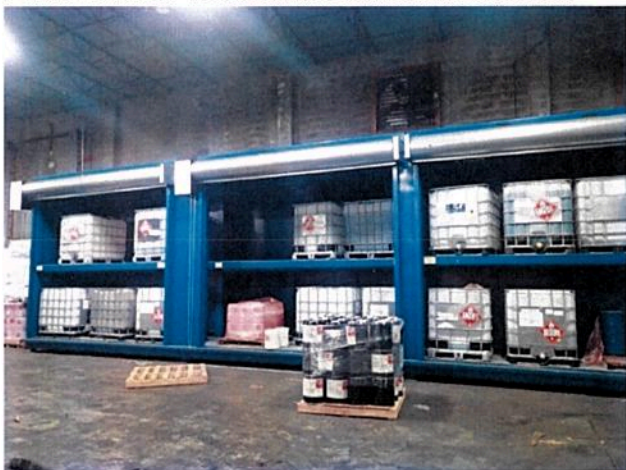
Photo 13 of 24: Dennison Unit

The inspection team was lead to the product storage location where a Dennison Unit was present (Photo 13 of 24). This unit is designed to store flammable products and is flame resistant. Some of the products being stored in the unit included ink cleaner, solvent blends, super 16 paint gun cleaner and solvent 106. Adjacent to the unit was an open 5-gallon bucket of used oil that was not labeled with the words "Used Oil" (Photo 14 of 24).

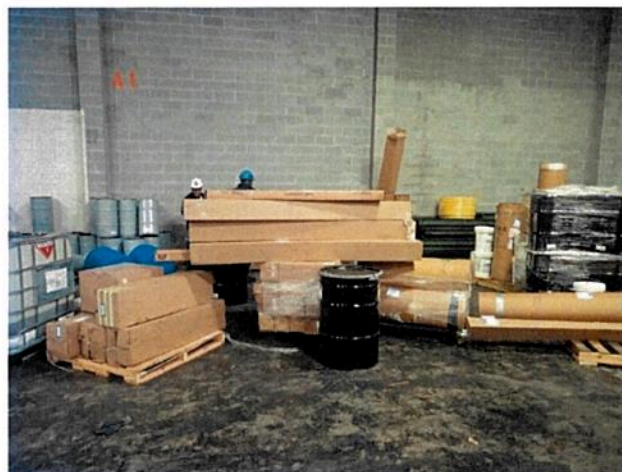
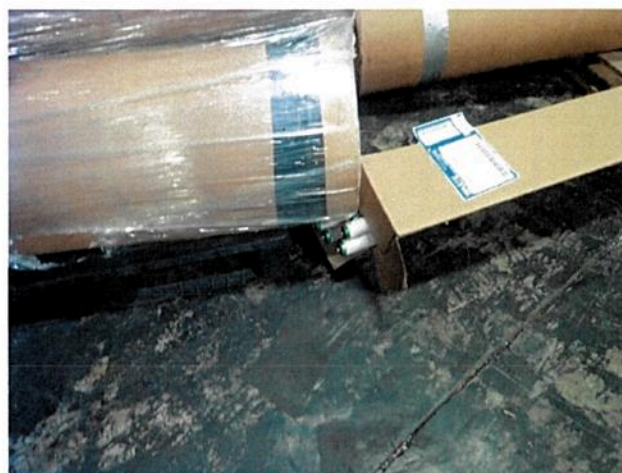
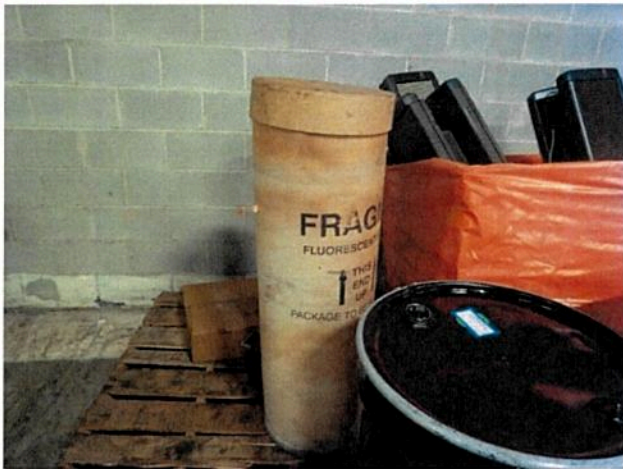
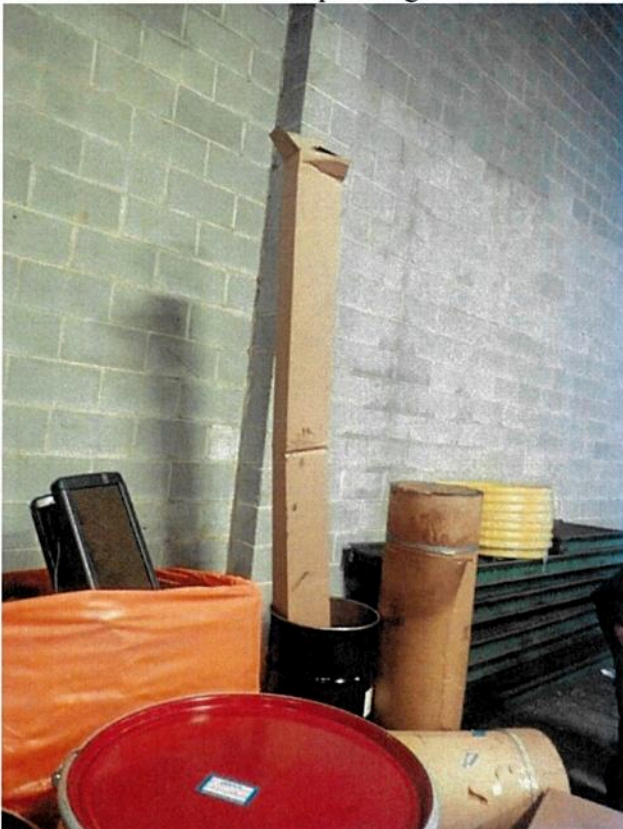
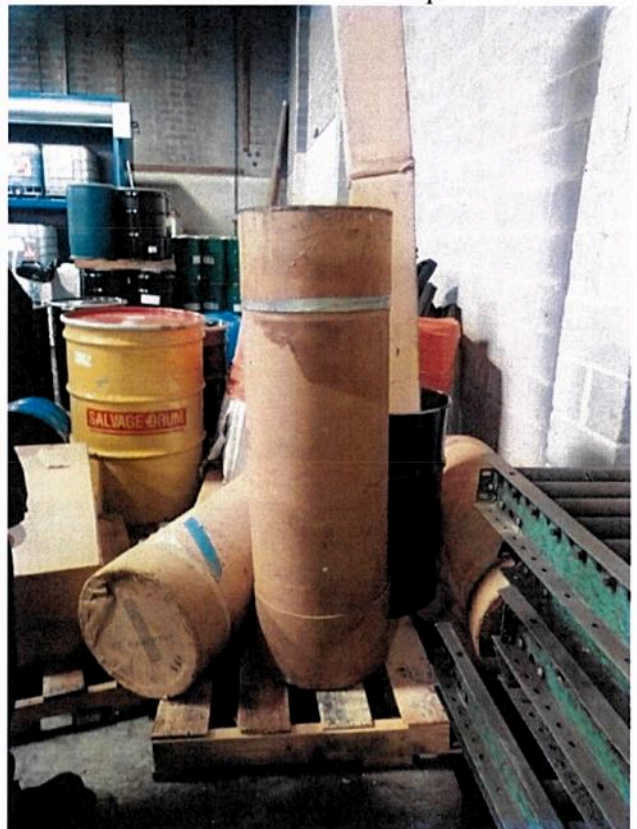
Located adjacent to the Dennison Unit was the storage for universal waste lamps (Photos 15-21 of 24). The inspectors noted three cylindrical 4-foot boxes and one 12-foot box of used lamps that were not labeled with any universal waste language. Two of the three cylindrical 4-foot boxes were not closed. The facility representative stated that the method HCC uses to determine how long universal waste has been stored at their location is by dating the container. At the time of the inspection, the containers accumulating the used lamps did not display an accumulation start date.

Photo 15 of 24: Universal waste (UW) lamp storage area

Photo 16 of 24: UW lamp storage

Photo 17 of 24: UW lamp Storage

Photo 18 of 24: UW lamp storage

Photo 19 of 24: UW lamp storage in 55-gallon container with broken UW lamp

Photo 21 of 24: UW lamp storage

Pursuant to Ga. Comp. R. and Regs. 391-3-11-18 [40 C.F.R. § 273.14(e) (2016)], a SQHUW must label or mark each lamp or container of lamps clearly with one of the following phrases: "Universal Waste-Lamp(s)," or "Waste Lamp(s)," or "Used Lamps."

Pursuant Ga. Comp. R. and Regs. 391-3-11-18 [40 C.F.R. § 273.13(d)(1) (2016)], a SQHUW must manage universal waste lamps in containers or packages that are structurally sound, adequate to prevent breakage, and compatible with the contents of the lamps. Such containers must remain closed.

Pursuant to Ga. Comp. R. and Regs. 391-3-11-18 [40 C.F.R. § 273.15(a) and (c) (2016)], a SQHUW may accumulate universal waste no longer than one year and must to be able to demonstrate the length of time that the universal waste has accumulated from the date that it became a waste or was received.

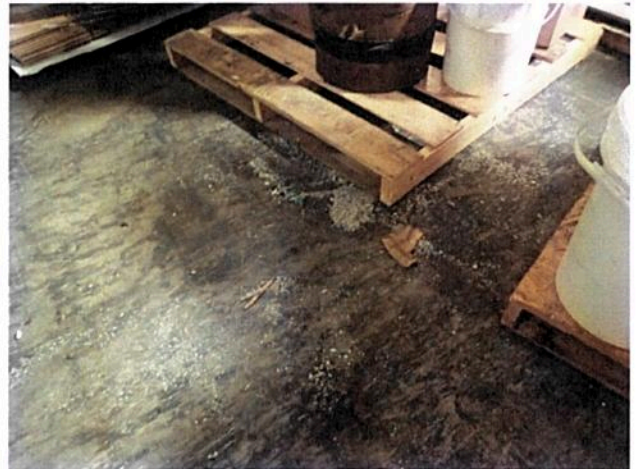
Photo 20 of 24: Broken UW lamp

A 55-gallon container located in the universal waste storage area held broken remnants of a used lamp. There were crushed lamps on the floor in this area. These crushed lamps appeared to be discarded. The facility had not conducted a hazardous waste determination on these crushed lamps.

Pursuant to Ga. Comp. R. and Regs. 391-3-11-.08(1) [40 C.F.R. § 262.11 (2016)], a person who generates a solid waste, as defined in Ga. Comp. R. and Regs. 391-3-11-.07(1) [40

C.F.R. § 261.2 (2016)], must determine if that waste is a hazardous waste following the methods articulated in Ga. Comp. R. and Regs. 391-3-11-.08(1) [40 C.F.R. § 262.11 (2016)].

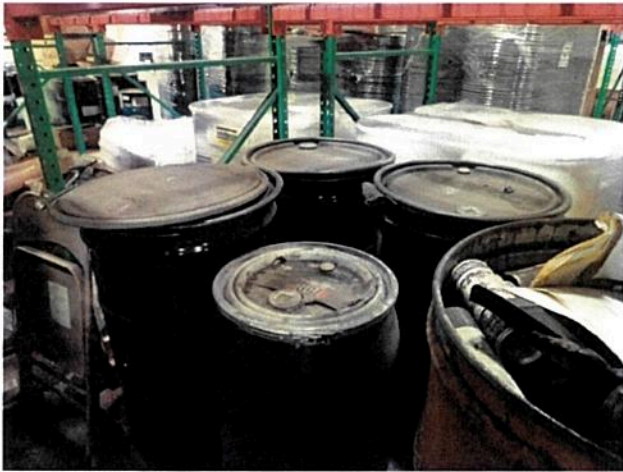
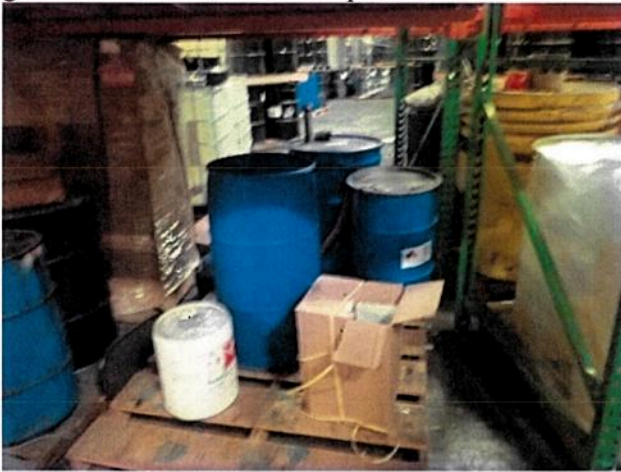
In the Rack Area, HCC stored one 85-gallon yellow container that the inspection team asked the facility representative to open. Inside the 85-gallon yellow container was approximately five aerosol cans of All Purpose Spray Adhesive on top of a 55-gallon metal container. The aerosol cans appeared to be discarded. The facility had not made a waste determination on the discarded waste. The contents of the 55-gallon metal container were unknown.

There was one open 55-gallon container storing used oil that was in poor condition (Photos 22-24 of 24).

Photo 22 of 24: Rack area with a used oil container, a 55-gallon container inside an 85-gallon container, and multiple aerosol cans

Photo 24 of 24: Rack area

Photo 23 of 24: Rack area

Pursuant to Ga. Comp. R. and Regs. 391-3-11-.08(1) [40 C.F.R. § 262.11 (2016)], a person who generates a solid waste, as defined in Ga. Comp. R. and Regs. 391-3-11-.07(1) [40 C.F.R. § 261.2 (2016)], must determine if that waste is a hazardous waste following the methods articulated in Ga. Comp. R. and Regs. 391-3-11-.08(1) [40 C.F.R. § 262.11 (2016)].

Pursuant to Ga. Comp. R. and Regs. 391-3-11-.17(1) [40 C.F.R. § 279.22(b)(1) (2016)], containers and aboveground tanks used to store used oil at generator facilities must be in good condition (no severe rusting, apparent structural defects or deterioration).
